**STANDARD DESIGN FOR COUNCIL LEVEL  
 HOSPITALS IN TANZANIA**

**SECURITY HOUSE  
 FLOOR PLAN**

**SECURITY HOUSE**  
 TYPICAL SECTIONS

**SECURITY HOUSE  
ELEVATIONS**

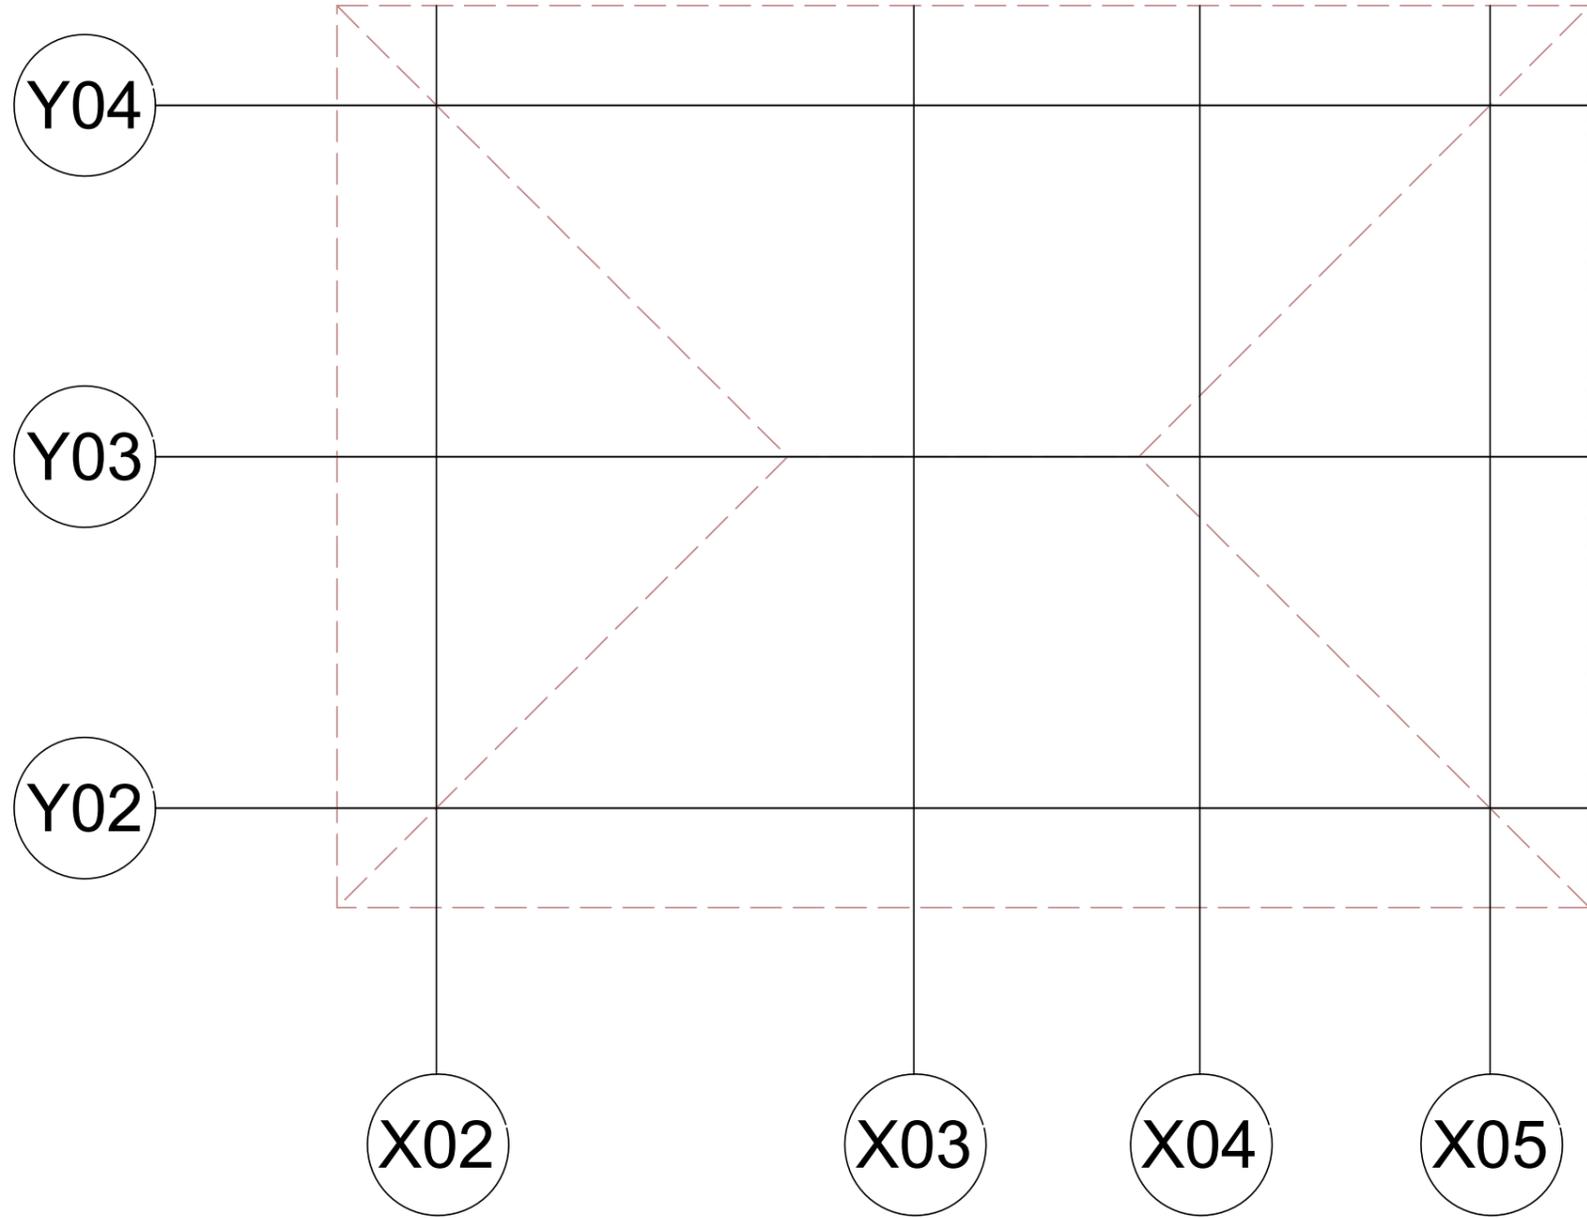
DRAWING TITLE		
<b>SECURITY HOUSE</b>		
ROOF LAYOUT PLAN		
PROJECT NO.		<b>SH A/102</b>
DRAWN BY:	IAS	
CHECKED BY:	DCNM	
DATE	MAY,2018	SCALE 1:100

IT 5 Resincot Aluzinc Sheets on  
 Pressure Impregnated Ceiling Battens to Manufacturers Details on  
 Pressure Impregnated Roof Trusses/ Rafters to Engineers Details on  
 100 x 50 mm Pressure Impregnated Wall Plate  
 50 x 50mm Pressure Impregnated Ceiling Brandening at 60 x 1200 Centres

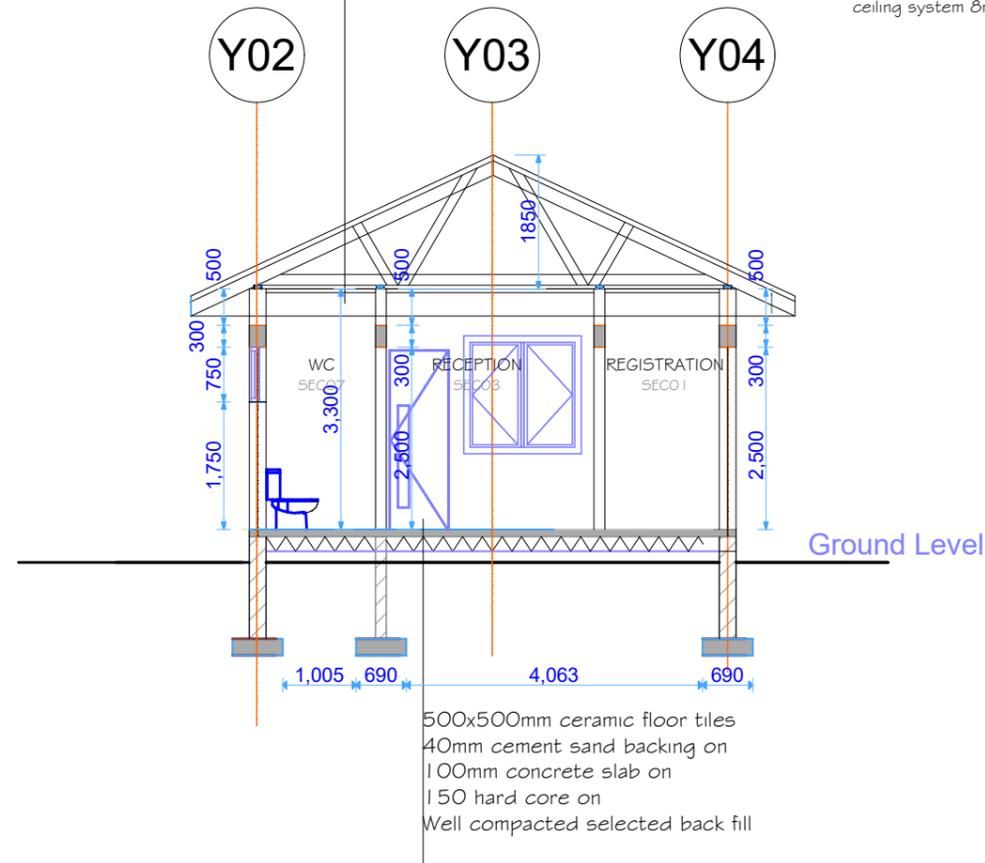
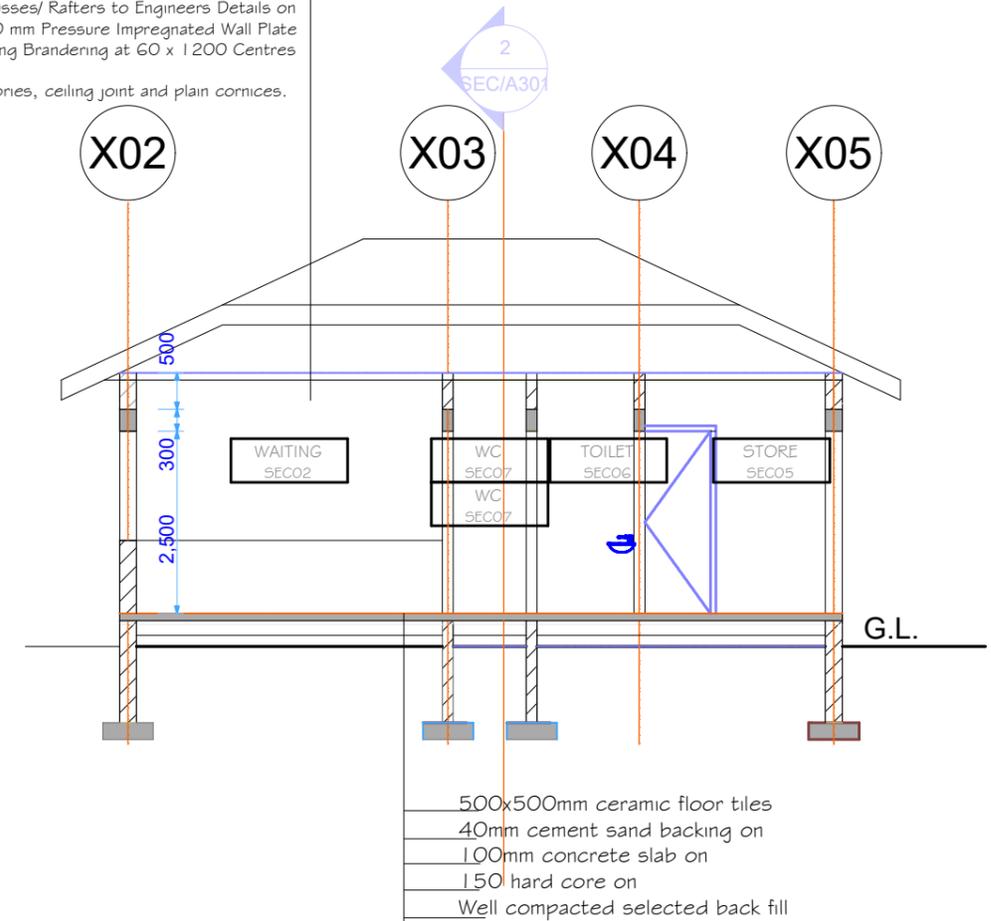
**SH A /201**

IT 5 Resincot Aluzinc Sheets on  
 Pressure Impregnated Ceiling Battens to Manufacturers Details on  
 Pressure Impregnated Roof Trusses/ Rafters to Engineers Details on  
 100 x 50 mm Pressure Impregnated Wall Plate  
 50 x 50mm Pressure Impregnated Ceiling Brandening at 60 x 1200 Centres  
 ceiling system 8mm thick with an epoxy coating including all necessary accessories, ceiling joint and plain cornices.
